Flood Control Project Maintenance
2014 Structure Summary Report
Overall Unit and Item Ratings

Butte County Department of Public Works

Big Chico Creek Diversion Structure

Flood Control Project Maintenance**Unit Cover Sheet****2014 Structure Inspection Results****Butte County Department of Public Works**

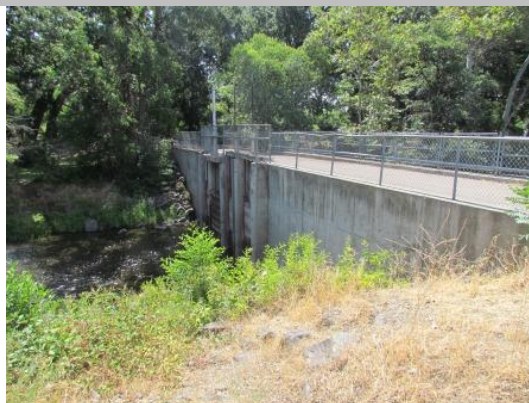
Photo 1 of 3 : ST_2014_NA0003_35_1_20140721_00004.jpg

This is a view of the structure from upstream.

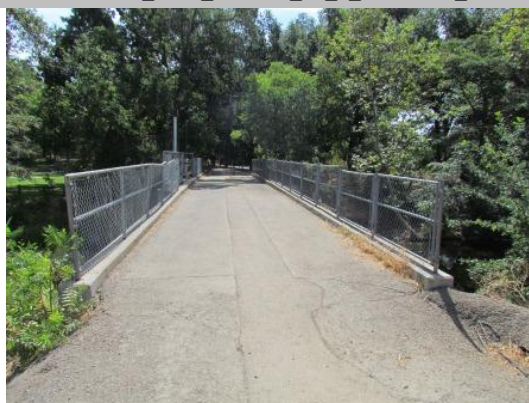
Photo 2 of 3 : ST_2014_NA0003_35_1_20140721_00005.jpg

This is a view of the structure from the bike path.

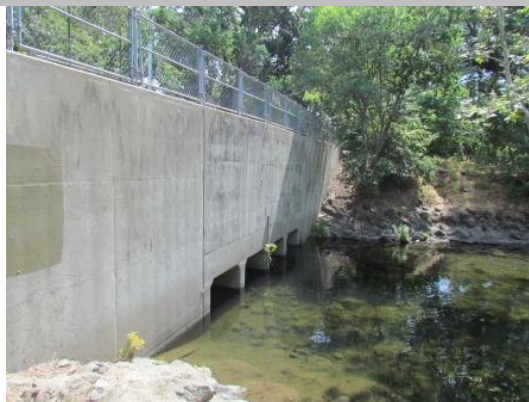
Photo 3 of 3 : ST_2014_NA0003_35_1_20140721_00006.jpg

This is a view of the structure from downstream.

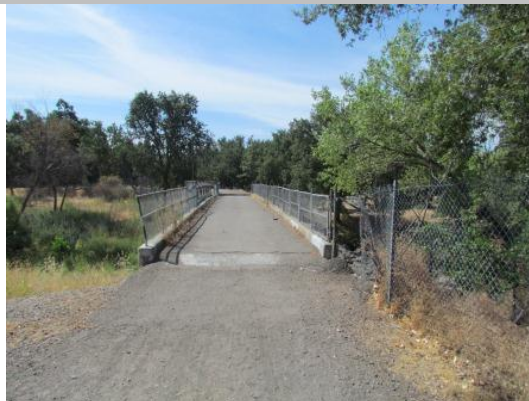
Photo 1 of 3 : ST_2014_NA0003_48_1_20140721_00004.jpg

This is a view of the structure from the bike trail.

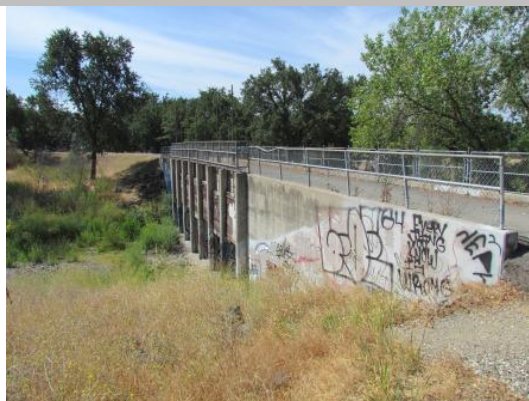
Photo 2 of 3 : ST_2014_NA0003_48_1_20140721_00005.jpg

This is a view of the structure from upstream.

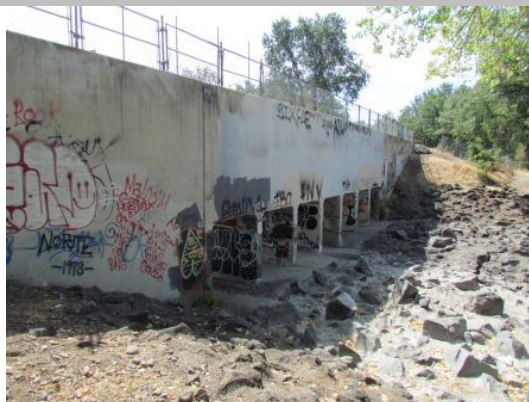
Photo 3 of 3 : ST_2014_NA0003_48_1_20140721_00006.jpg

This is a view of the structure from downstream.

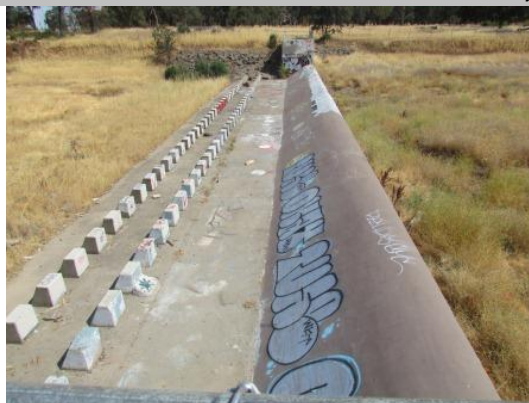
Photo 1 of 3 : ST_2014_NA0003_8_1_20140721_00002.jpg

This is a view of the weir.

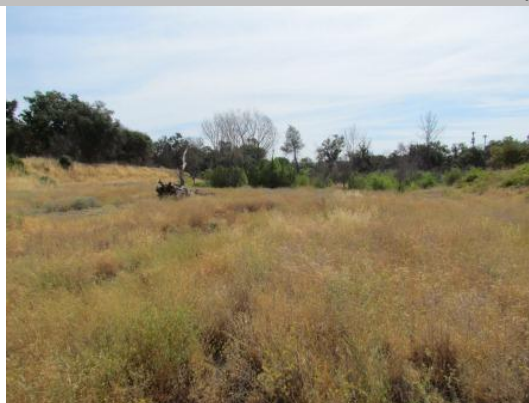
Photo 2 of 3 : ST_2014_NA0003_8_1_20140721_00003.jpg

This is a photo of the upstream side of the weir.

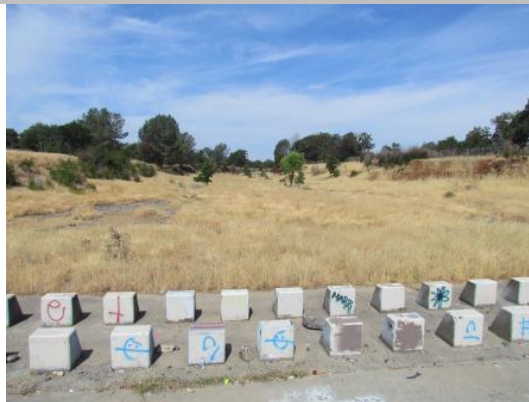
Photo 3 of 3 : ST_2014_NA0003_8_1_20140721_00004.jpg

This is a photo of the downstream side of the weir.
